Common Causes of Return

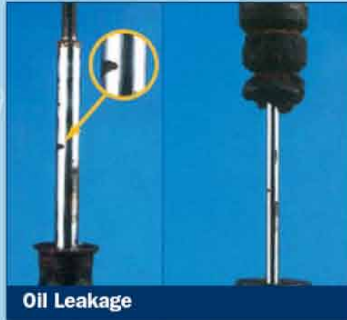
Oil Leakage

- CAUSE:** Chrome peeled off/leakage.
- ? Worn out bumper + dust shield.
 - ! Check and replace with new bumper and dust shield.

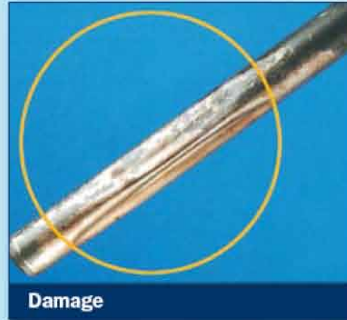
Damage

- CAUSE:** Abnormal damage or rust of the cartridge tube (accident damage, product abused or the presence of water inside strut housing).
- ? No oil put in the strut housing during assembly of the strut cartridge.
 - ! Handle product with care prior to fitment, always put 50cc oil in strut for correct heat conduction.

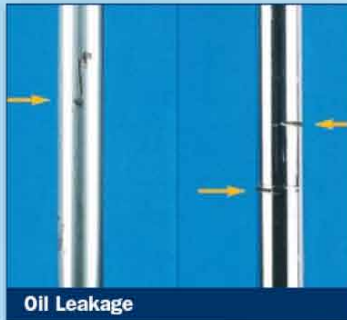
Oil Leakage

- CAUSE:** Piston rod chrome surface damaged (by vice grips or pliers).
- ? Piston rod and oil seal damaged after using pliers or grips during installation.
 - ! Use the correct mounting tool to avoid the piston rod turning during the tightening of the central top nut.

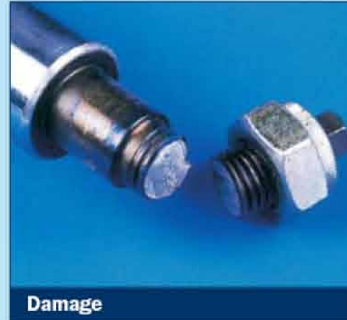
Damage

- CAUSE:** Stem end broken off.
- ? Tightened with power tool. Top bearing blocked (if present).
 - ! Apply correct tightening torques (refer to vehicle manufacturer's specifications). Use correct tool. Check and replace upper bearing if necessary.

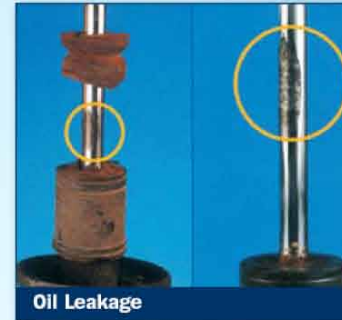
Oil Leakage

- CAUSE:** Chrome surface worn off at one side. Oil leakage.
- ? Piston rod submitted to strong side-load, due to the tightening of the mountings with wheels hanging, suspension components bent, or incorrectly adjusted wheel alignment.
 - ! Only fully tighten shock absorber mountings with the wheels on the ground (shock absorber in working position). Inspect suspension components for signs of wear or impact damage.

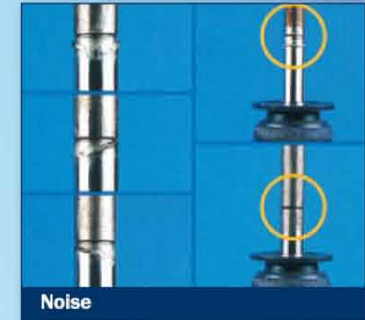
Noise

- CAUSE:** Knocking noise. Piston rod circlip damaged/out of groove.
- ? Piston rod nut over-tightened forcing circlip from groove, or insufficiently tightened allowing movement of the mounting components causing circlip to be pushed out of groove.
 - ! Apply correct tightening torques (refer to vehicle manufacturer's specifications).

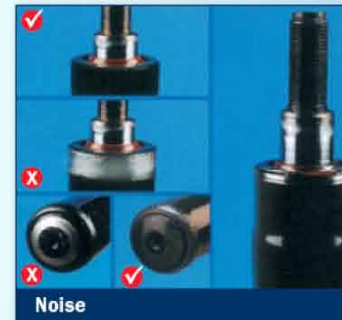
Noise

- CAUSE:** Knocking noise. Paint worn off at bottom and on top of cartridge housing. Broken sealing (see right picture).
- ? Cartridge not tightened correctly. Old locking ring reused. Not all provided parts used if needed (new locking ring/spacer/centering cap).
 - ! Apply correct tightening torques (refer to vehicle manufacturer's specifications). Use all provided parts according to the mounting instructions. Use correctly. Always check for movement of the cartridge once locking ring is tightened to specifications.

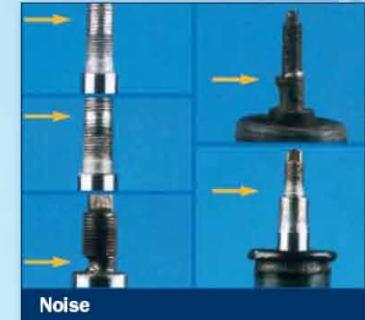
Noise

- CAUSE:** Knocking noise. Irregular damage of the piston rod stem thread.
- ? Mounting parts mounted incompletely or not put in the correct order. Mounting parts too tight or too loose after mounting.
 - ! Ensure all mounting parts assembled in the correct order and tightened to the correct specification (refer to vehicle manufacturer's specifications).
